Manhole Inspection Summary

Manhole # S33U__011MH

Insp Date: **8/15/08 2:35 PM**

Location Address: **rear 1600 clarkson st**

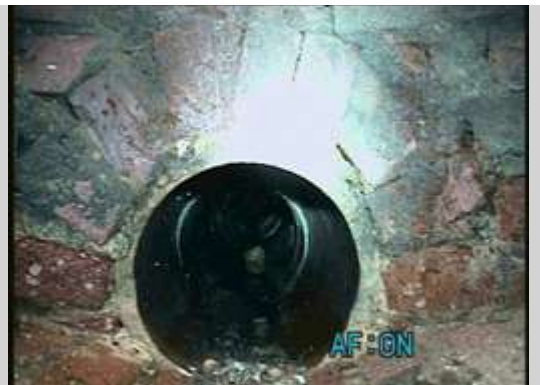
12 O'Clock Outflow

8 in. Circular Gravity Sewer
Pipe Out @ 12 O'Clock

Pipe Height: **0** (in.) Direct

Pipe Material: **Clay** ☐ Pipe Lined

Infiltration: **None** Pipe Seal Cond: **Unknown**
